Project Name: Castlewood Business Park- Plot 8
Project Description: WinCan Import in Miraculix Standard
Project Date: 21/07/2022

Company: Winvic Construction
Description: CCTV Drainage Survey
Contact: David Gilbert
Department: Vertical Build
Street: Plot 8
Town or City: Castlewood

Company: Oakley Industrial Services LTD
Description: CCTV Drainage Surveys
Contact: Colin Clarke
Department: Drainage
Street: Enterprise Park
Town or City: Corby
County: Northants
Post Code: NN17 5JE
Phone: 01536 206179
Mobile: 07747 844248
Email: colin@theoakleygroup.com

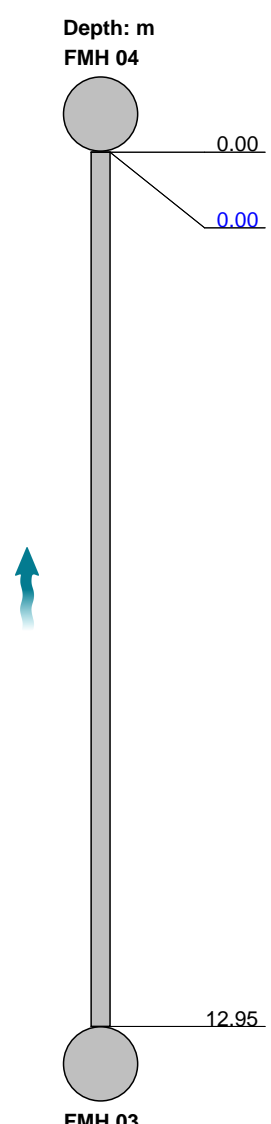
</div>										0.00	MH	Start node, manhole, reference: FMH 04	00:00:00					0.00	WL	Water level, 0% of the vertical dimension	00:00:01					12.95	MHF	Finish node, manhole, reference: FMH 03	00:00:42		
		0.00	MH	Start node, manhole, reference: FMH 04	00:00:00																										
		0.00	WL	Water level, 0% of the vertical dimension	00:00:01																										
		12.95	MHF	Finish node, manhole, reference: FMH 03	00:00:42																										
Construction Features				Miscellaneous Features																											
Structural Defects				Service & Operational Observations																											
STR No. Def	STR Peak	STR Mean	STR Total	STR Grade	SER No. Def	SER Peak	SER Mean	SER Total	SER Grade																						
0	0.0	0.0	0.0	0.0	0	0.0	0.0	0.0	0.0

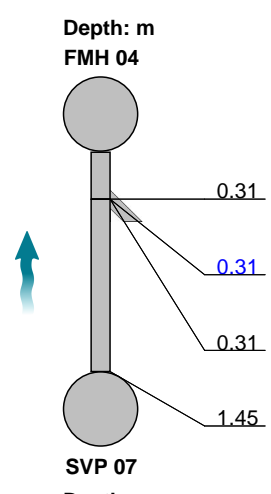
MH	Start node, manhole, reference: FMH 04	00:00:00		
		0.31	WL	Water level, 0% of the vertical dimension	00:00:00		
		0.31	JN	Junction at 10 o'clock, 100mm dia	00:00:01		
		1.45	BRF	Finish node, major connection without manhole, reference: SVP 07	00:00:14		
		SVP 07					
		Depth: m

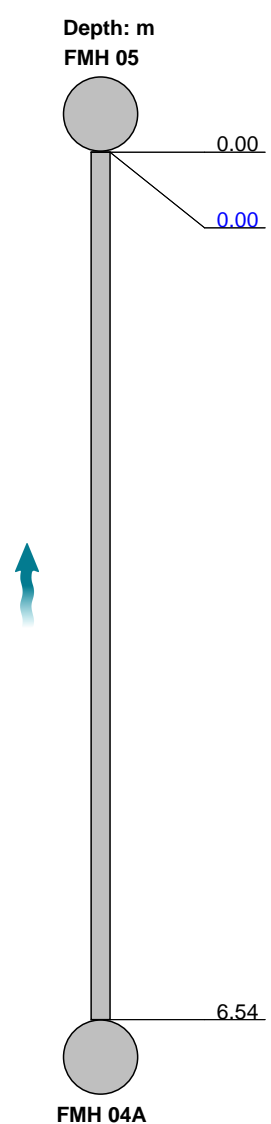
</div>								0.00	MH	Start node, manhole, reference: FMH 04A	00:00:00	0.00	WL	Water level, 0% of the vertical dimension	00:00:00	6.54	MHF	Finish node, manhole, reference: FMH 05	00:00:13
0.00	MH	Start node, manhole, reference: FMH 04A	00:00:00																
0.00	WL	Water level, 0% of the vertical dimension	00:00:00																
6.54	MHF	Finish node, manhole, reference: FMH 05	00:00:13																
Construction Features				Miscellaneous Features															
Structural Defects				Service & Operational Observations															
STR No. Def	STR Peak	STR Mean	STR Total	STR Grade	SER No. Def	SER Peak	SER Mean	SER Total	SER Grade										
0	0.0	0.0	0.0	0.0	0	0.0	0.0	0.0	0.0

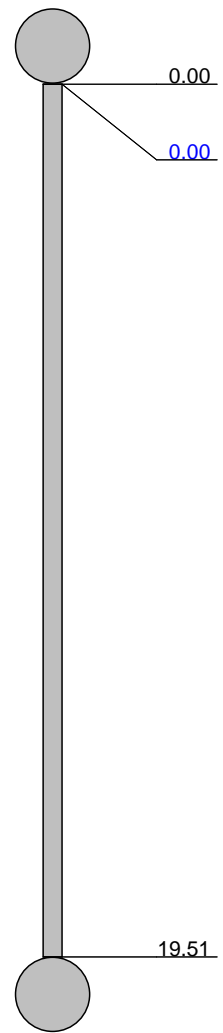
</div>								0.00		MH	Start node, manhole, reference: SMH 01	00:00:00			0.00		WL	Water level, 0% of the vertical dimension	00:00:01			19.51		GYF	Finish node, gully, reference: ACO 1	00:01:46		
0.00		MH	Start node, manhole, reference: SMH 01	00:00:00																								
0.00		WL	Water level, 0% of the vertical dimension	00:00:01																								
19.51		GYF	Finish node, gully, reference: ACO 1	00:01:46																								
Construction Features				Miscellaneous Features																								
Structural Defects				Service & Operational Observations																								
STR No. Def	STR Peak	STR Mean	STR Total	STR Grade	SER No. Def	SER Peak	SER Mean	SER Total	SER Grade																			
0	0.0	0.0	0.0	0.0	0	0.0	0.0	0.0	0.0
